XC3S200 FPGA Errata and Deviations from Spartan-3 Data Sheet

DS099-E03 (v2.2) December 20, 2004

Errata Notice

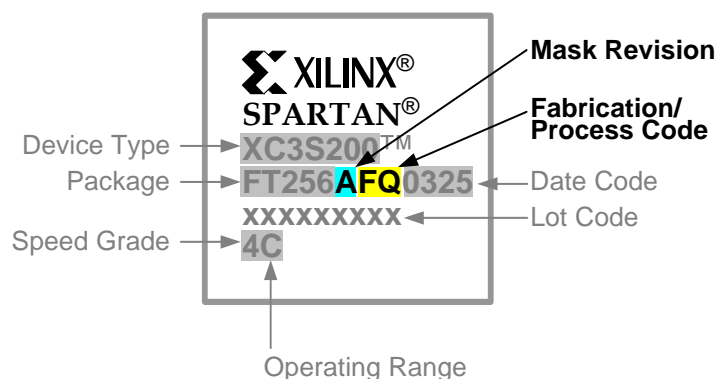
Figure 1: Spartan-3 FPGA from UMC 200 mm facility with “FQ” Fabrication/Process Code Marking

This issue only affects the XC3S200 FPGAs shown in [Table 4](#), marked with the “AFQ” mask/fabrication/process code as shown in [Figure 1](#).

The DCM compensates for delay on the routing network by monitoring an output clock, either CLK0 or CLK2X, through a BUFGMUX. If a design uses the CLK2X output as the feedback clock for a DCM, the LOCKED output may go Low and the DCM may stop operating correctly after tens of milliseconds.

Use feedback from the CLK0 (through a BUFGMUX) instead of CLK2X and change the CLK_FEEDBACK attribute from 2X to 1X. There is no difference in DCM performance. The CLK2X output is still valid and available for the application but it cannot be used for feedback to the CLKFB pin.

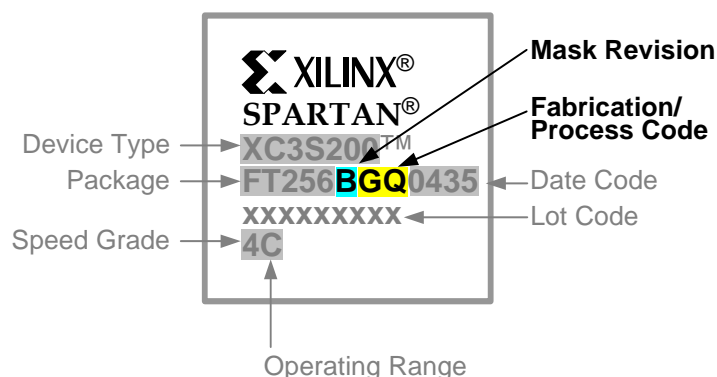
Figure 2: Spartan-3 FPGA from UMC 300 mm facility with “GQ” Fabrication/Process Code Marking

This issue only applies to those designs using the Readback feature on the XC3S200 FPGAs shown in [Table 8](#) with a "BGQ" Fabrication/Process Code marking, as shown in [Figure 2](#). Few Spartan-3 applications actually use the Readback feature. The CAPTURE_SPARTAN3 primitive is specifically required to use Readback.

The readback feature is not available.

This issue is corrected on XC3S200 FPGAs with a “BGQ” mask/fabrication/process code marking, as shown in [Figure 2](#).

There is no workaround for this issue.

Some logic monitoring functions available via Readback are also possible using the Xilinx ChipScope software.

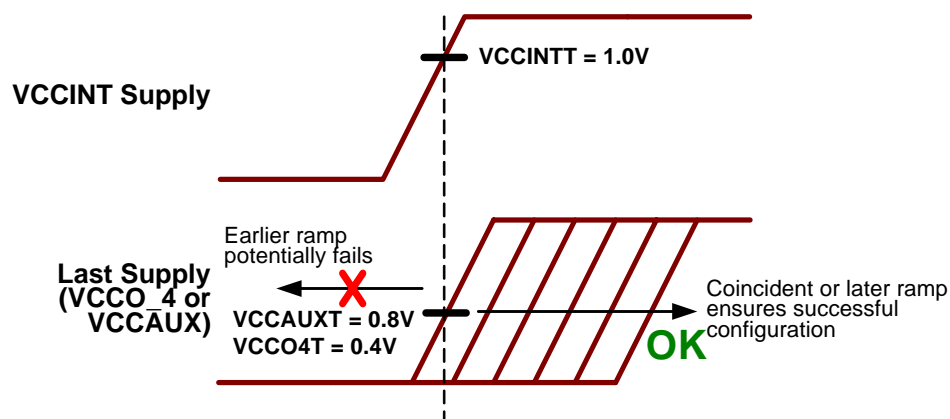
Figure 3: Requirements when VCCINT is not the Last Supply

Three voltage-supply inputs—VCCINT, VCCAUX and the VCCO supply to Bank 4—control the behavior of the Spartan-3 and Spartan-3L Power On Reset (POR) circuit. When applying power, a Power-On Reset (POR) circuit within the FPGA monitors each of these three rails. Once the voltages on each of the three rails exceed their respective POR thresholds, the POR circuit allows the FPGA to continue with its configuration process.

In the potentially failing condition, the VCCINT supply must be the last supply to reach its valid POR voltage and the ramp rate must be slower than 500 μ S. When the FPGA fails to configure, the INIT_B remains Low and the FPGA ignores the PROG_B program pin. Even with the worst identified power sequence, actual failures only occur on a small percentage of devices, typically measured in parts per million. The issue is more pronounced at cold temperatures.

Use a power-on sequence where VCCINT is not the last supply to reach its POR threshold level.

VCCINT must reach its maximum POR threshold ($VCCINTT = 1.0V$) before or coincident with VCCAUX reaching its minimum threshold ($VCCAUXT = 0.8V$). This supply sequence and threshold relationship is illustrated in [Figure 3](#).

Alternatively, VCCINT must reach its maximum POR threshold ($VCCINTT = 1.0V$) before or coincident with VCCO_4 supplying I/O bank 4 reaching its minimum threshold ($VCCO4T = 0.4V$). This supply sequence and threshold relationship is also illustrated in [Figure 3](#).

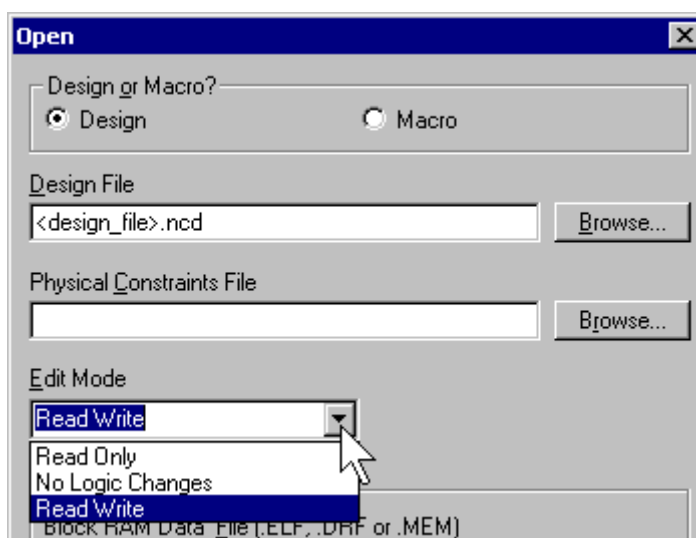
Figure 5: Enable User Editing in FPGA Editor

The DCM automatically compensates for process, voltage, and temperature (PVT) changes and consequently it periodically updates its delay tap settings. The rate at which the update occurs is controlled by an internal attribute called FACTORY_JF. Xilinx has identified an optimal FACTORY_JF setting value (FACTORY_JF=8080). Other settings may potentially fail to track properly over process, voltage, and temperature.

Without using the optimal settings, the DCM could potentially, with low probability, fail to assert the LOCKED output, could lose lock, or could produce erroneous clock outputs.

- Invoke the FPGA Editor. On Windows PCs, select **Start → Xilinx ISE 6 → Accessories → FPGA Editor**.
- Select **File → Open**. Select the *.ncd file for the completed design. Set the **Edit Mode** to "Read Write" mode as shown in [Figure 5](#).
