XC3S200 FPGA Errata and Deviations from Spartan-3 Data Sheet

DS099-E03 (v2.3) January 28, 2005

Errata Notice

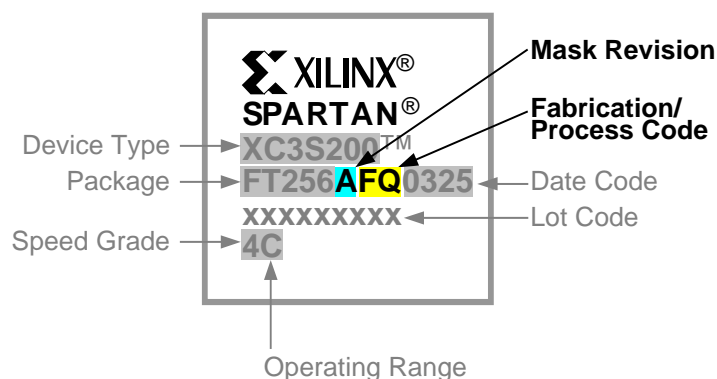
Figure 1: Spartan-3 FPGA from UMC 200 mm facility with “FQ” Fabrication/Process Code Marking

This issue only affects the XC3S200 FPGAs shown in [Table 4](#), marked with the “AFQ” mask/fabrication/process code as shown in [Figure 1](#).

The DCM compensates for delay on the routing network by monitoring an output clock, either CLK0 or CLK2X, through a BUFGMUX. If a design uses the CLK2X output as the feedback clock for a DCM, the LOCKED output may go Low and the DCM may stop operating correctly after tens of milliseconds.

Use feedback from the CLK0 (through a BUFGMUX) instead of CLK2X and change the CLK_FEEDBACK attribute from 2X to 1X. There is no difference in DCM performance. The CLK2X output is still valid and available for the application but it cannot be used for feedback to the CLKFB pin.

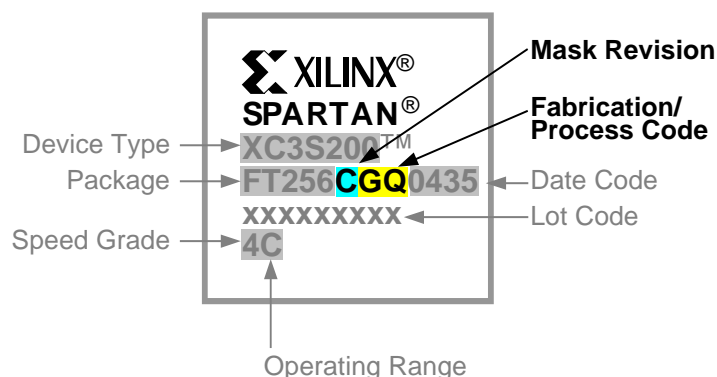
Figure 2: Spartan-3 FPGA from UMC 300 mm facility with “GQ” Fabrication/Process Code Marking

This issue only applies to those designs using the Readback feature on the XC3S200 FPGAs shown in [Table 8](#) with a “CGQ” Fabrication/Process Code marking, as shown in [Figure 2](#). Few Spartan-3 applications actually use the Readback feature. The CAPTURE_SPARTAN3 primitive is specifically required to use Readback.

The readback feature is not available.

There is no workaround for this issue.

Some logic monitoring functions available via Readback are also possible using the Xilinx ChipScope software.

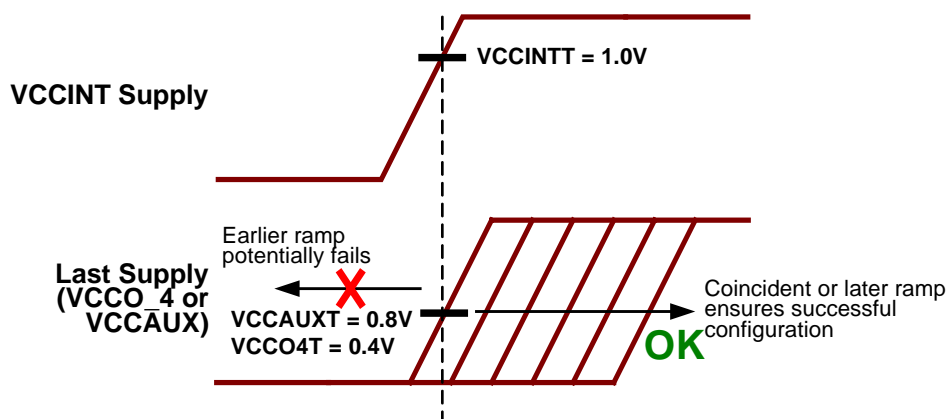
Figure 3: Requirements when VCCINT is not the Last Supply

In the potentially failing condition, the VCCINT supply must be the last supply to reach its valid POR voltage and the ramp rate must be slower than 500 μ S. When the FPGA fails to configure, the INIT_B remains Low and the FPGA ignores the PROG_B program pin. Even with the worst identified power sequence, actual failures only occur on a small percentage of devices, typically measured in parts per million. The issue is more pronounced at cold temperatures.

Use a power-on sequence where VCCINT is not the last supply to reach its POR threshold level.

VCCINT must reach its maximum POR threshold ($VCCINTT = 1.0V$) before or coincident with VCCAUX reaching its minimum threshold ($VCCAUXT = 0.8V$). This supply sequence and threshold relationship is illustrated in [Figure 3](#).

Alternatively, VCCINT must reach its maximum POR threshold ($VCCINTT = 1.0V$) before or coincident with VCCO_4 supplying I/O bank 4 reaching its minimum threshold ($VCCO4T = 0.4V$). This supply sequence and threshold relationship is also illustrated in [Figure 3](#).
